## Coal Mine Fatal Accident 2005-11&12

Operator:	Stillhouse Mining LLC
Mine:	Mine No. 1
Accident Date:	August 3, 2005
Classification:	Roof fall
Location:	Dist. 7, Harlan County, Kentucky
Mine Type:	Underground
Employment:	76
Production:	5,000 tons raw coal/day

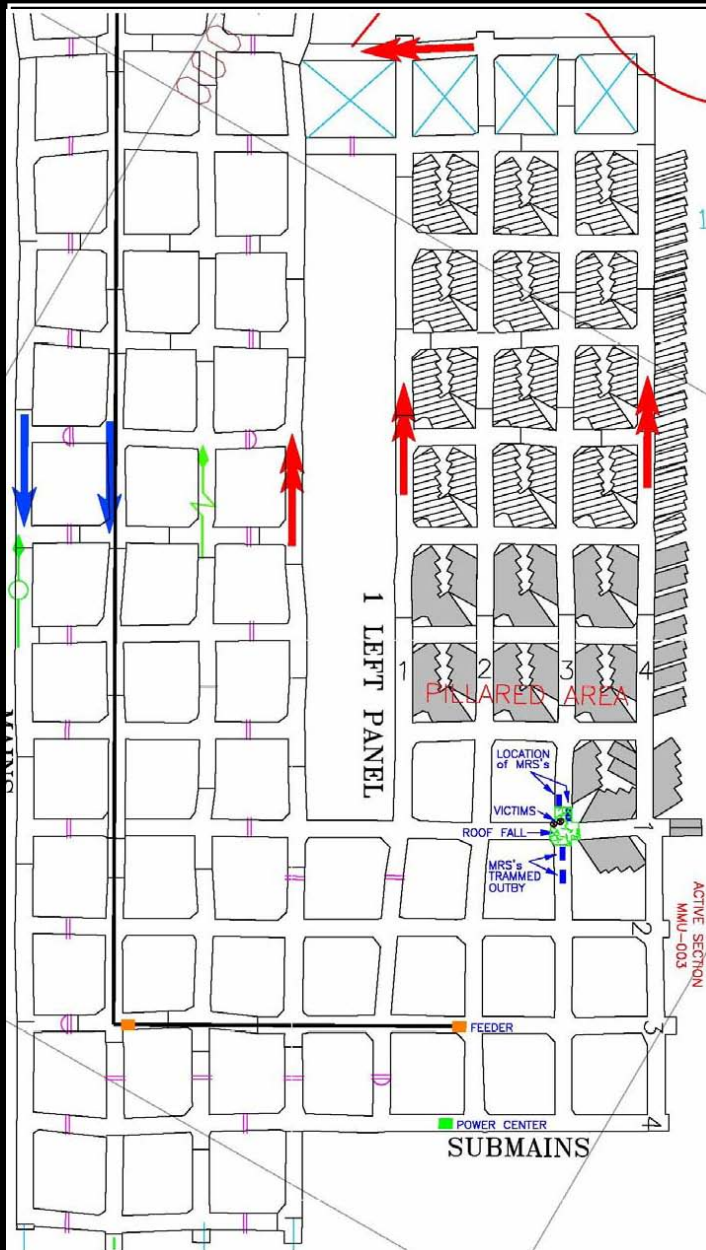
At approximately 7:00 a.m., the day shift entered the mine and set up the equipment to begin pillar recovery of the last pillar on the right side the 1 Left Panel. Instead of recovering pillars across the Submains from left to right, as directed by management, the day shift section foreman decided to recover the last row of pillars from the 1 Left Panel, mining from right to left.

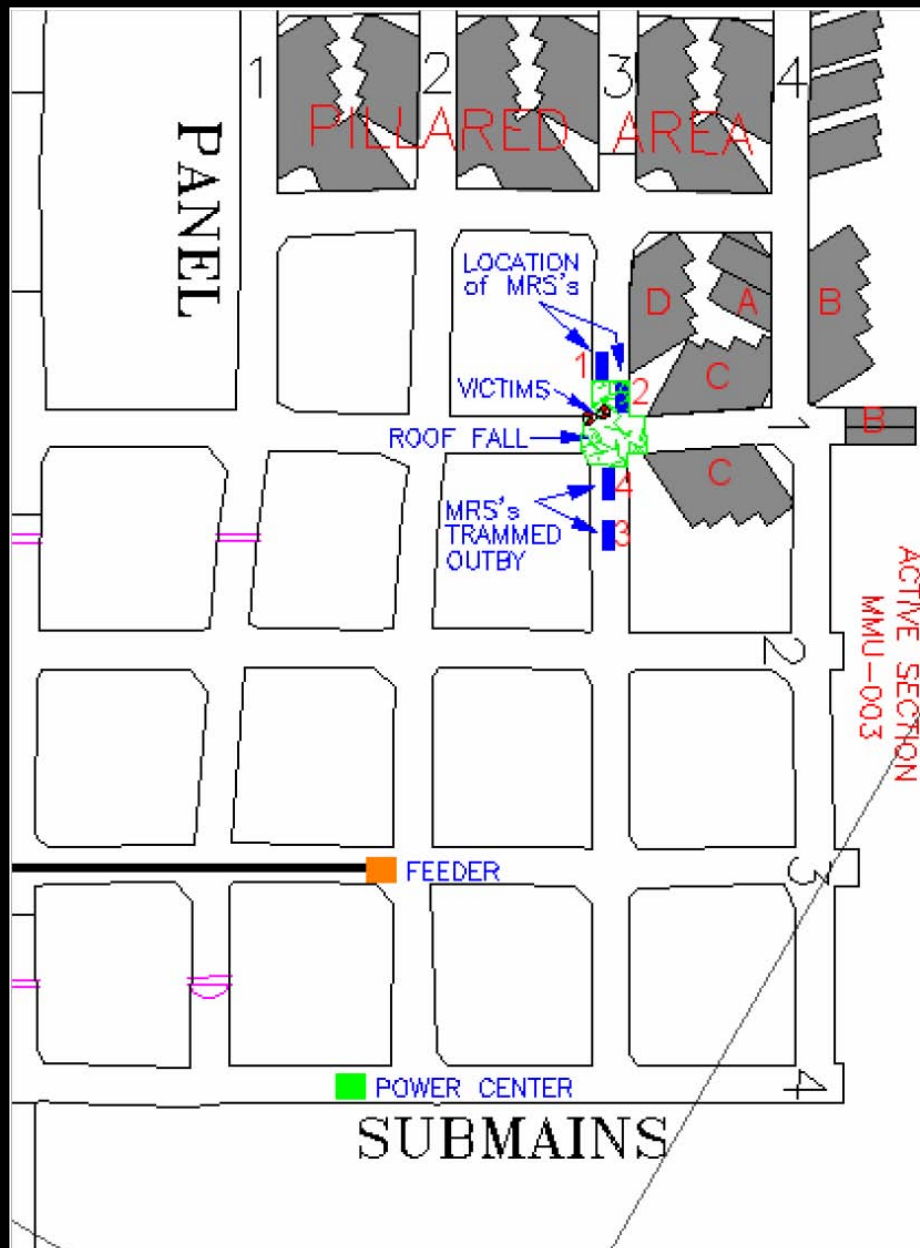
Alternating mining lifts were commenced to the left and right from the 1 Left Panel No. 4 entry (cuts A and B). After the fourth lift (B) was mined to the right of the entry, the conveyor belt stopped allowing time for the continuous mining machine cable to be rerouted, and breaker timbers to be set in the last open crosscut between the Submains Nos. 1 and 2 entries. After the belt was started, they mined three more lifts (B) to the right of the No. 4 entry and two 30 foot lifts straight off the inby end of the Submains No. 1 entry.

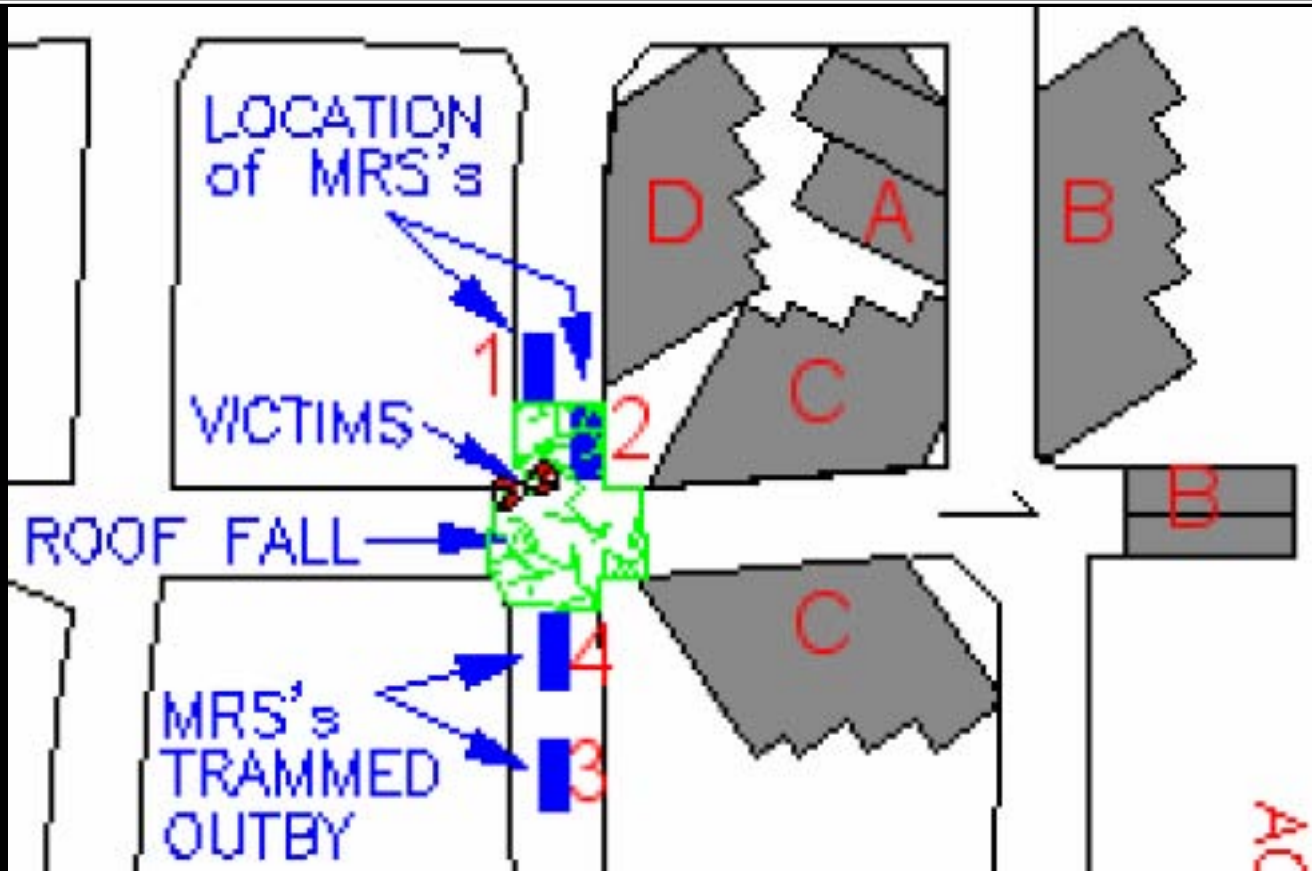
At approximately 3:00 p.m., the second shift crew entered the mine. The second shift continuous mining machine operator mined alternating left and right lifts (C) from the Submains No. 1 entry. The MRS units were moved as the lift sequence advanced. At about the time that the second lift was being mined, a shuttle car operator, noticed that the roof was working in the Submains No.1 entry, outby the intersection with the No. 3 entry of the 1 Left Panel. He informed a MRS operator of the condition.

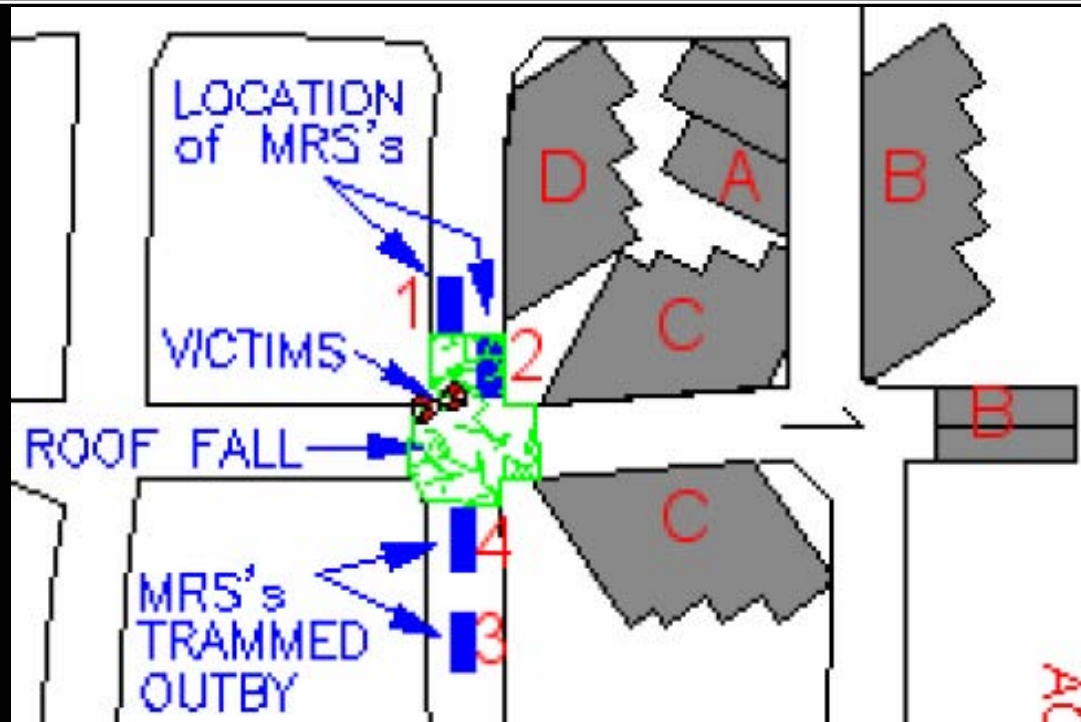
The MRS operator checked two 6-foot test holes and no hazards were detected. He then checked a 12 foot test hole in the affected intersection and found a separation at 11 feet and 5 inches. He told victim A, the section foreman, about the crack. Victim A checked the 12-foot test hole, but took no corrective action and made no further mention about the matter. The MRS operator continued checking to see if the separation was widening after every two or three shuttle cars. While mining was being conducted in region C, The MRS operator told another supervisor about the crack, the acting second shift mine foreman, but he indicated no concern regarding the condition. The MRS units were moved as each lift (C) was completed.

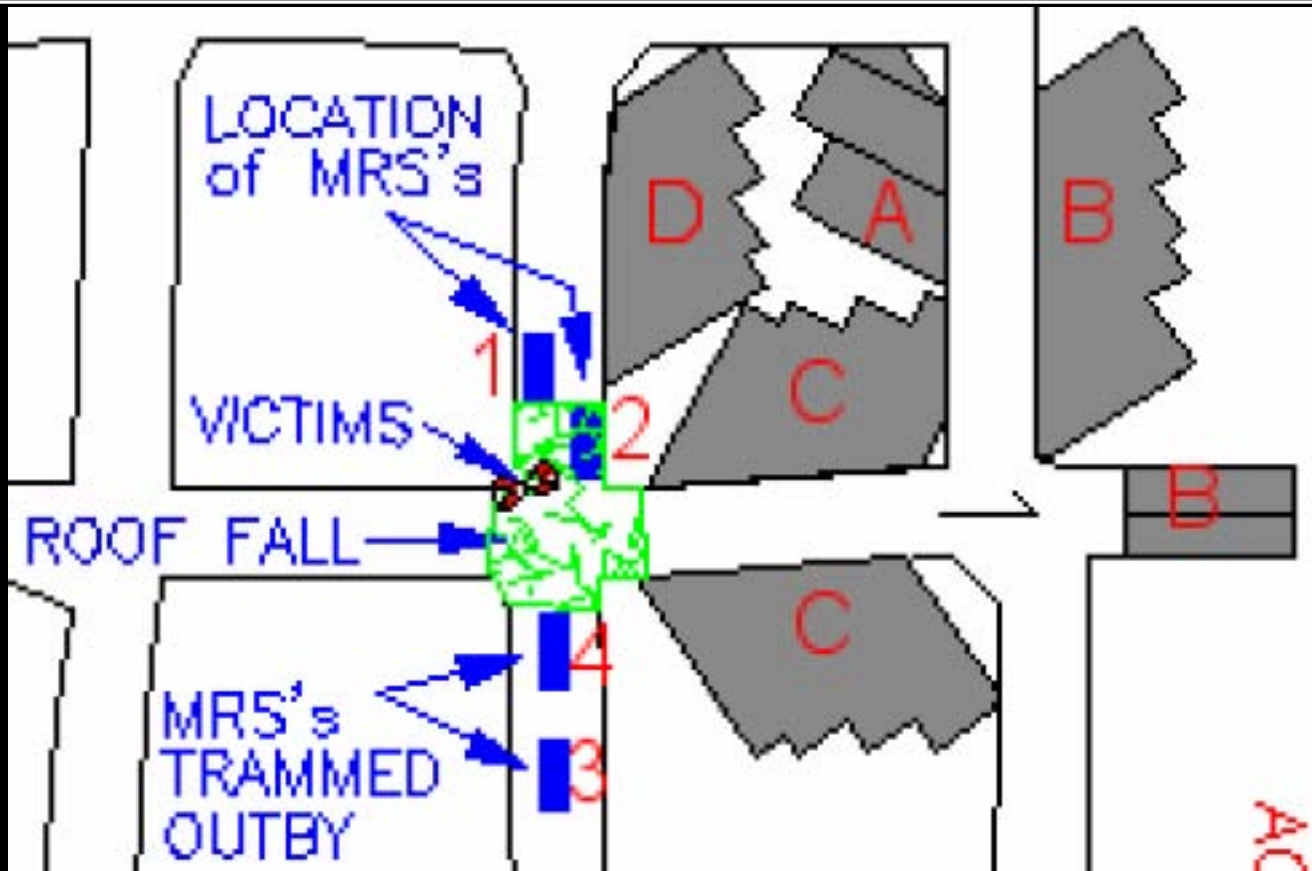
The MRS operator and a shuttle car operator, began moving the Nos. 1 and 2 MRS units forward. When they then attempted to push the fallen draw rock with the No. 1 MRS, the draw rock wedged between the coal rib and the No. 2 MRS track. They next began moving the Nos. 3 and 4 MRS units out of the Submains No. 1 entry. The MRS operator moved the No. 3 MRS to the midpoint of the crosscut between the Submains Nos. 1 and 2 entries. Next, he moved the No. 4 MRS behind the No. 3 MRS.

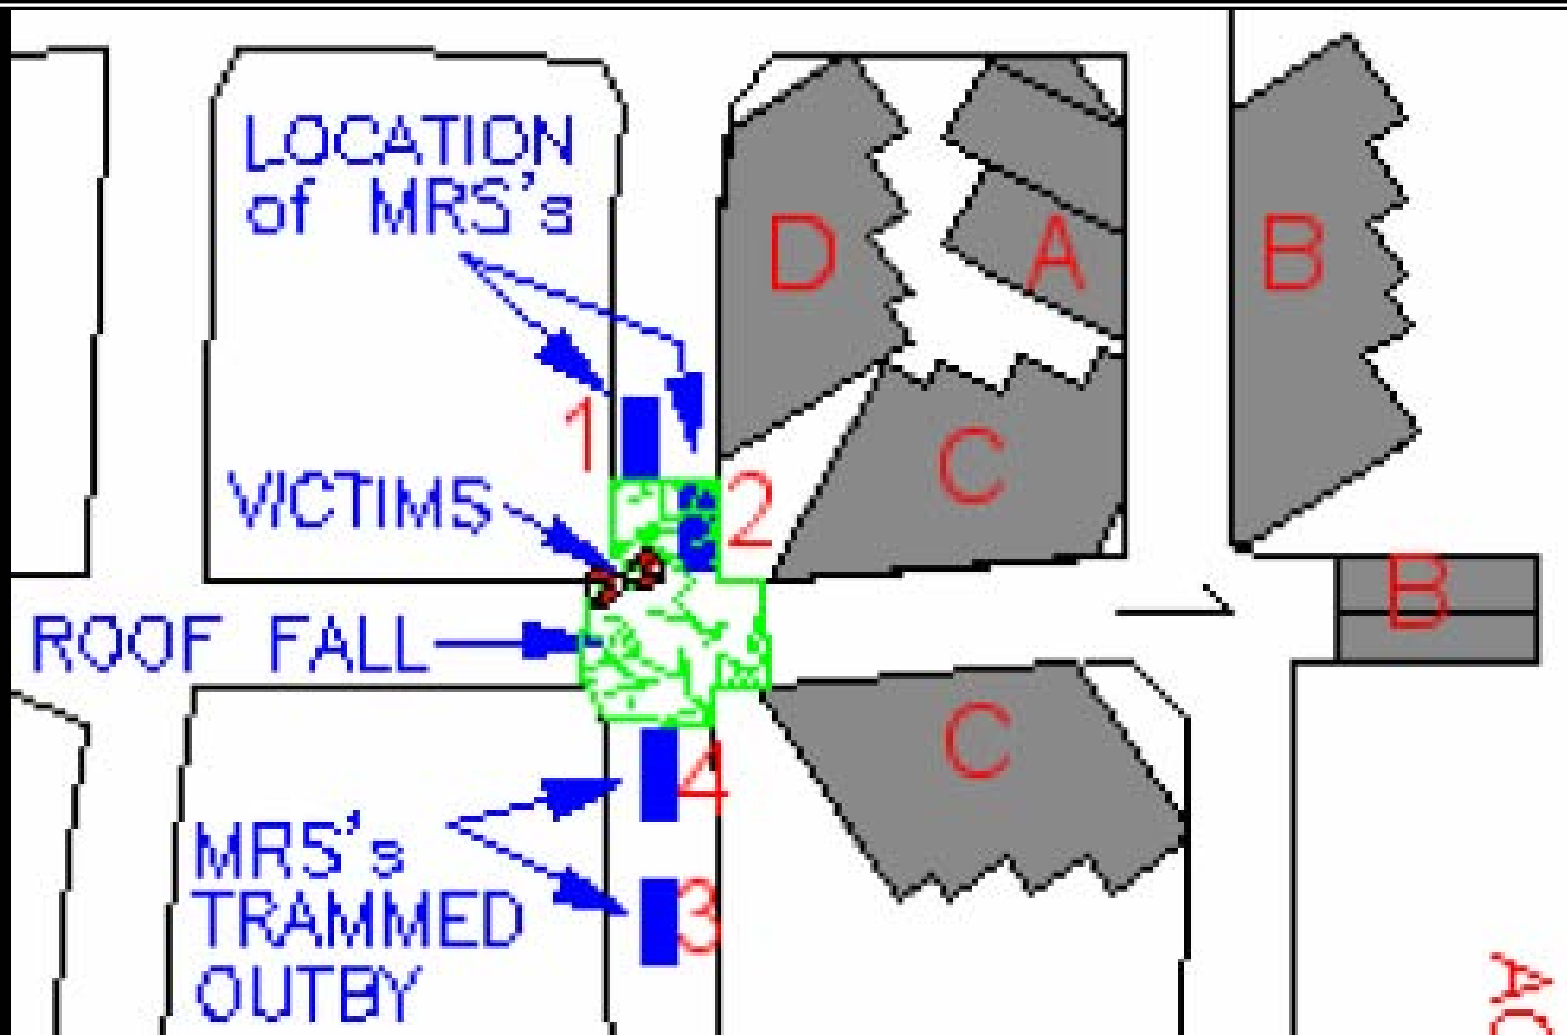
At this time, victims A and B were standing beside the No. 2 MRS, with victim A at the manual controls, when the mine roof fell, fatally injuring victims A and B. The fall extended from the front of the No. 1 MRS, through the intersection, and 13 feet into the crosscut to the back of the No. 4 MRS.

Mine management intended that pillar recovery be conducted from left to right across the Submains. Though the day shift section foreman knew this, he decided to mine right to left across the 1 Left Panel. Later that shift, the superintendent visited the section, saw the error, and instructed them to stop taking lifts out of that pillar. The day shift section foreman called out a preshift examination to victim A, which reported no hazards. They did not discuss what was mined or the pillar plan. The superintendent also did not inform the second shift. When the second shift began mining, they started using the left to right pillar plan across the Submains, as originally intended by mine management. Mine management did not change the cut sequence once the superintendent recognized that the intended cut sequence had been compromised.

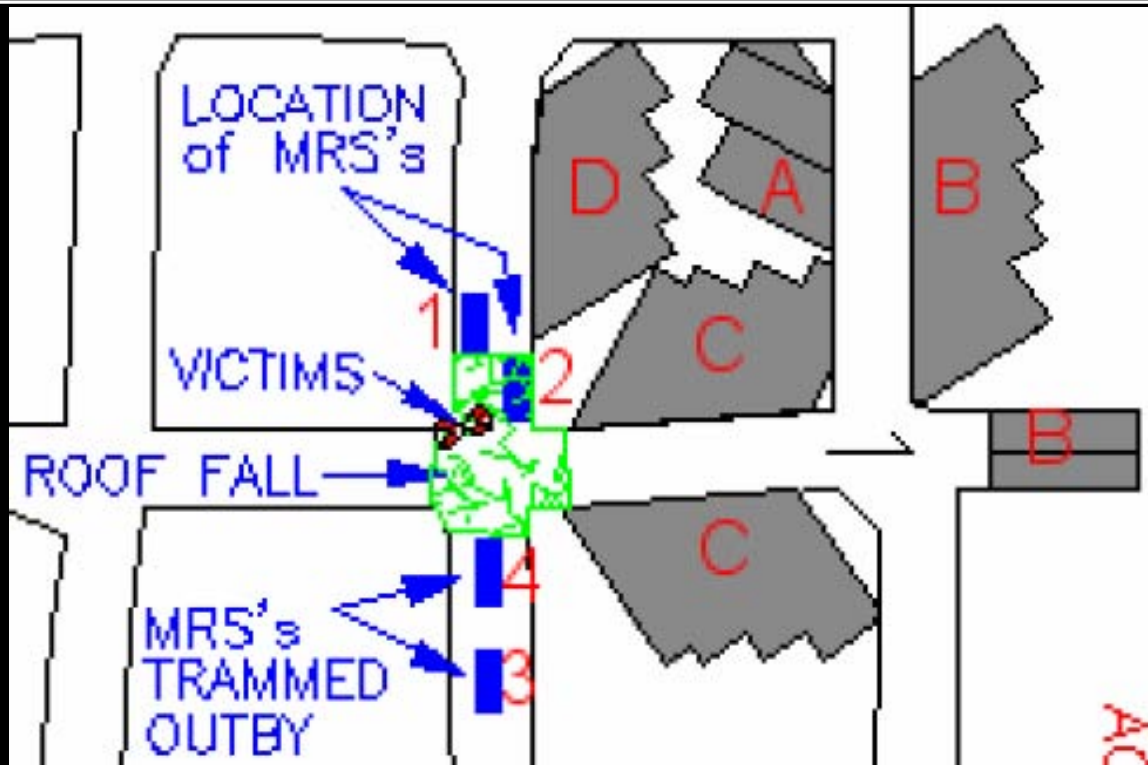
While mining the last lifts out of the pillar, miners were exposed to faulty pillar recovery methods. There were two roadways being utilized when mining the last lifts from the pillar. After the last lift was taken from the right side of the Submains No. 1 entry, the crosscut should have been blocked by the No. 3 and 4 MRS units and only the roadway through the Submains No. 1 entry used. The continuous mining machine cable was also located through the crosscut, which was located adjacent to a pillar that had been reduced in size with no additional roof support provided.

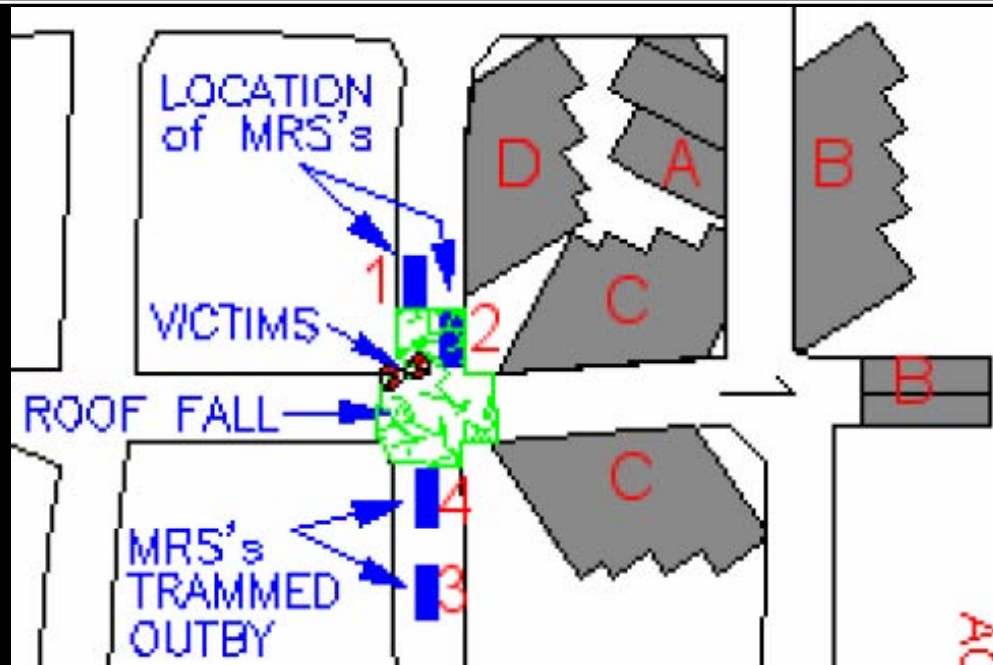
The approved Roof Control Plan required MRS units to be moved sequentially in pairs so that each unit would not be offset more than one half unit length from its companion unit. However, this provision was not being complied with at the time of the accident. To comply with the plan, the No. 2 MRS should not have been moved past the No. 1 MRS and the Nos. 3 and 4 MRS units should have remained set until the Nos. 1 and 2 MRS units were brought forward into the intersection. Also, the MRS operators were not in a remote location while moving the MRS units, they were in the intersection. This exposed the victims to hazards associated with inadequately supported roof immediately adjacent to the incorrectly positioned MRS units and faulty cut sequence.

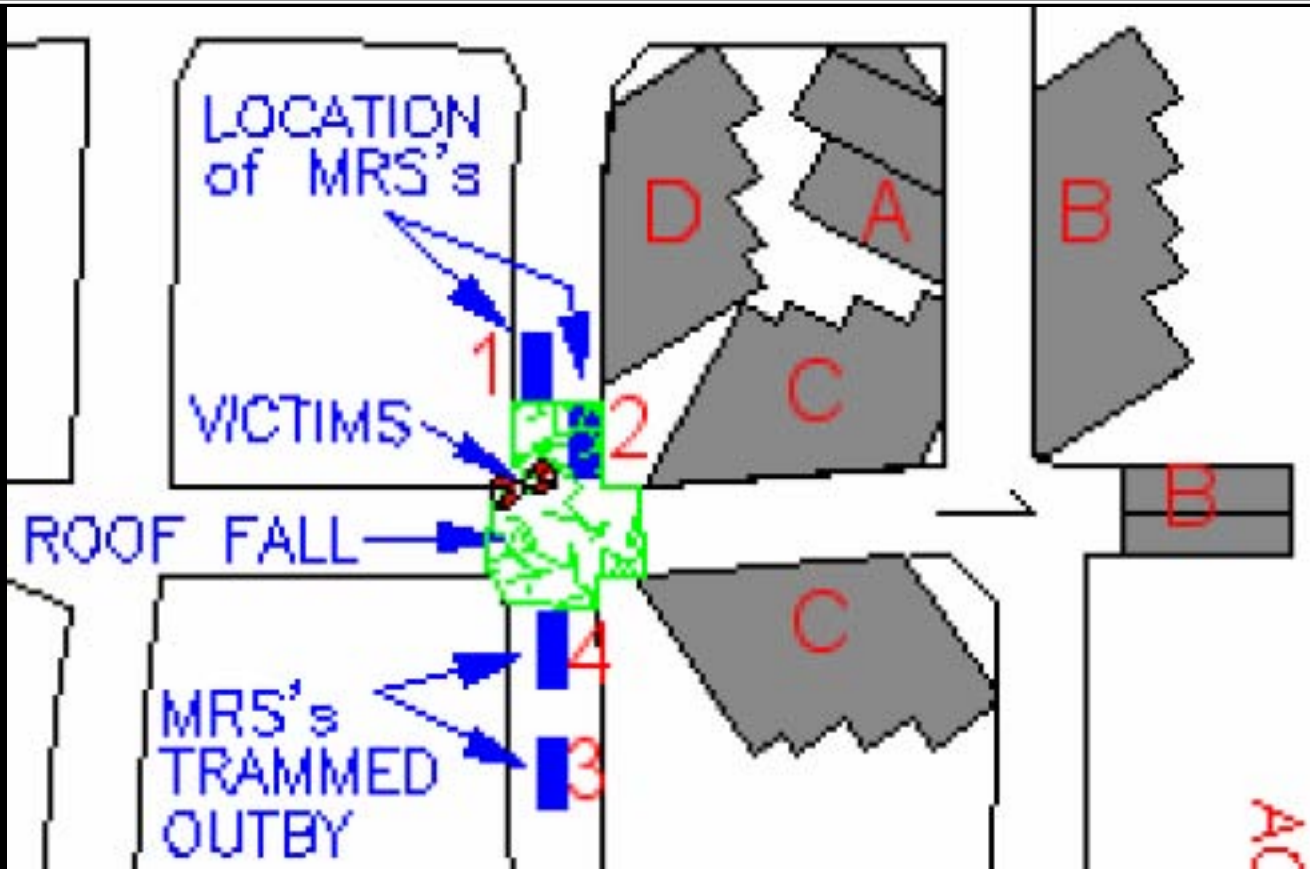
Mine management failed to post the area where a separation had been detected in a roof test hole with a conspicuous danger sign or take corrective action.

Two section foremen, one of whom was victim A, knew about the separation at 11 feet and 5 inches, in the intersection. The MRS operator informed victim A about the separation, and this was confirmed by a witness. Also, a different witness confirmed that Boggs told Rutherford about the separation.
